Erstellungsdatum: 20090129

Service Bulletin

**1. HDS 9/16 / 12/14 ST Gas
ionization electrode (6.526-216)****Service Bulletin
No. 2007-033 dated 05.12.2007
Classification level II**

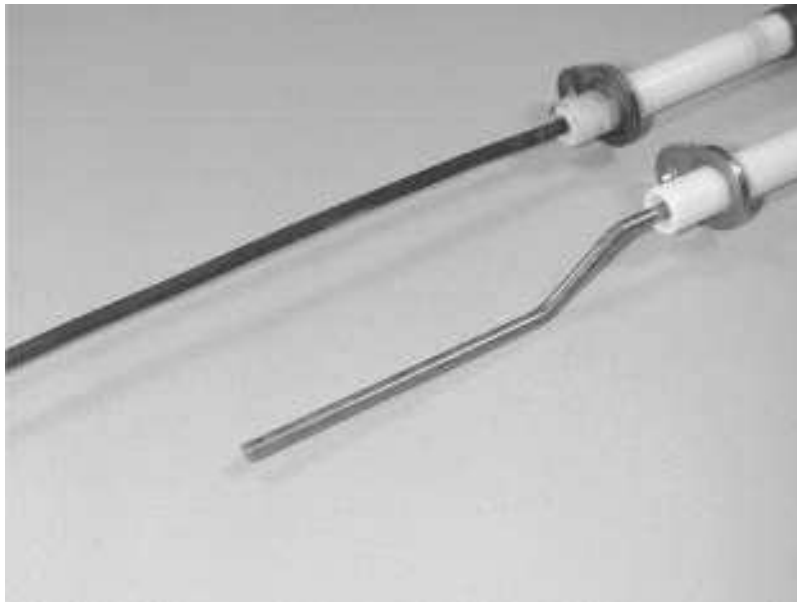
- Problem:** The short endurance of the ionization electrode frequently causes faults in the burner.
- Cause:** The long, straight shape together with the thermal load causes the ionization electrode to bend. A non-conductive oxide layer forms on the surface of the metal.
- Solution:** There is a new version of the ionization electrode, with different shape and material. The previous part number (6.526-216) is retained.
- Note 1:** Mount the ionization electrode at a distance of 8 to 10 mm to the fire tube and centrally to the hole in the ignition metal.

Fig. 1: Old (top) and new (bottom) version of the ionization electrode (6.526-216)

- Note 2:** When replacing the ionization electrode, please also fit the new ignition metal (5.044-832), see point 2 of this Service Bulletin.
- Note 3:** When replacing the ionization electrode and glow plug, please note:
- Replace O-ring 120 x 4 mm (6.362-954) on the burner flange and coat with silicone grease (e.g. 6.288-044).
 - Clean the contact area for the O-ring in the combustion chamber.
 - This is the only way to ensure that there is no leakage between burner flange and outer jacket.

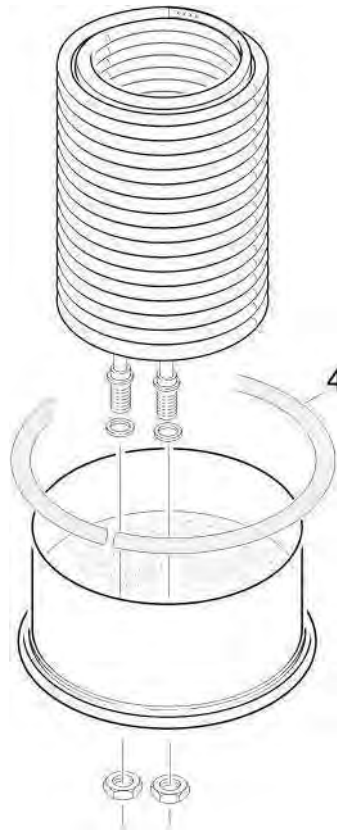
Note: Occasionally, the seal (6.363-205) between boiler base and outer jacket leaks.

The seal does not "lie" neatly in the seal edge or seal gap between outer jacket and base.

Fig. 1: Seal, No. 4 (6.363-205),
between outer jacket boiler base

Rub silicone grease (e.g. 6.288-044) thoroughly into the seal before fitting in the unit.

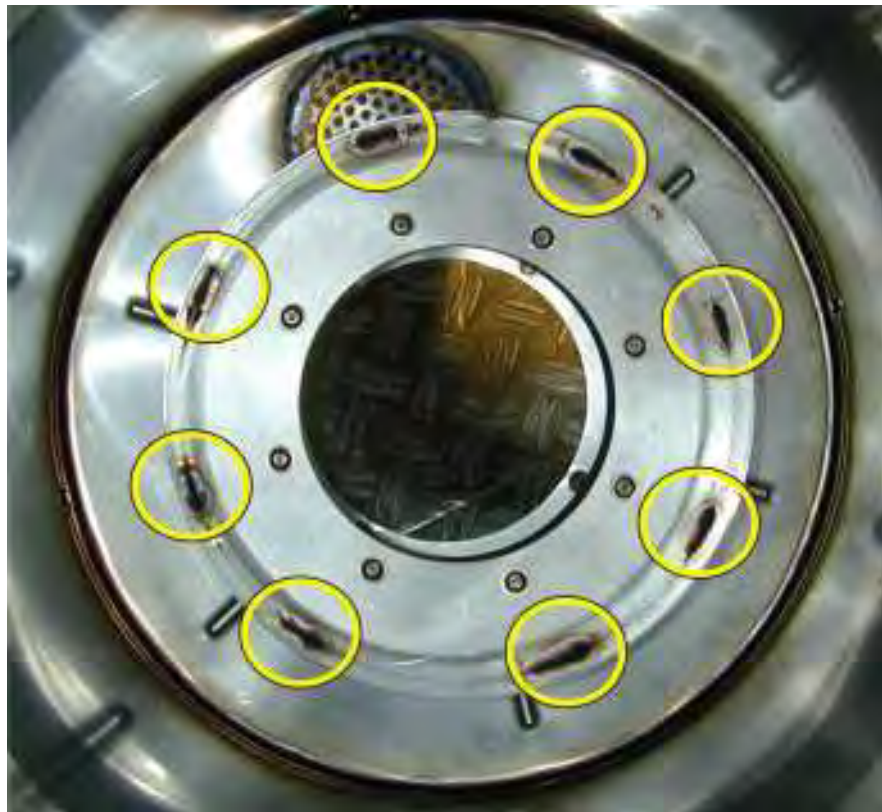
- Problem:** In units HDS 9/16 and 12/14 ST Gas (1.251-101/ -103/ -104/ -105/ -106), it is possible for the exhaust temperature of the burner to exceed the normal value. This may possibly trigger the exhaust temperature limiter.
- Cause:** The frame in the outer jacket (HDS 9/16 - 4.652-124 and HDS 12/14 - 4.652-142) does not have the specified number of 8 welding points. Thermal tension can cause the seam to open between the welding points.
- Solution:** If problems occur, then mount the correct outer jacket. The frame must be fastened with 8 welding points, see Fig. 1:

Fig. 1: View into the outer jacket from below.
In the correct version, the frame is held by 8 welding points (encircled).

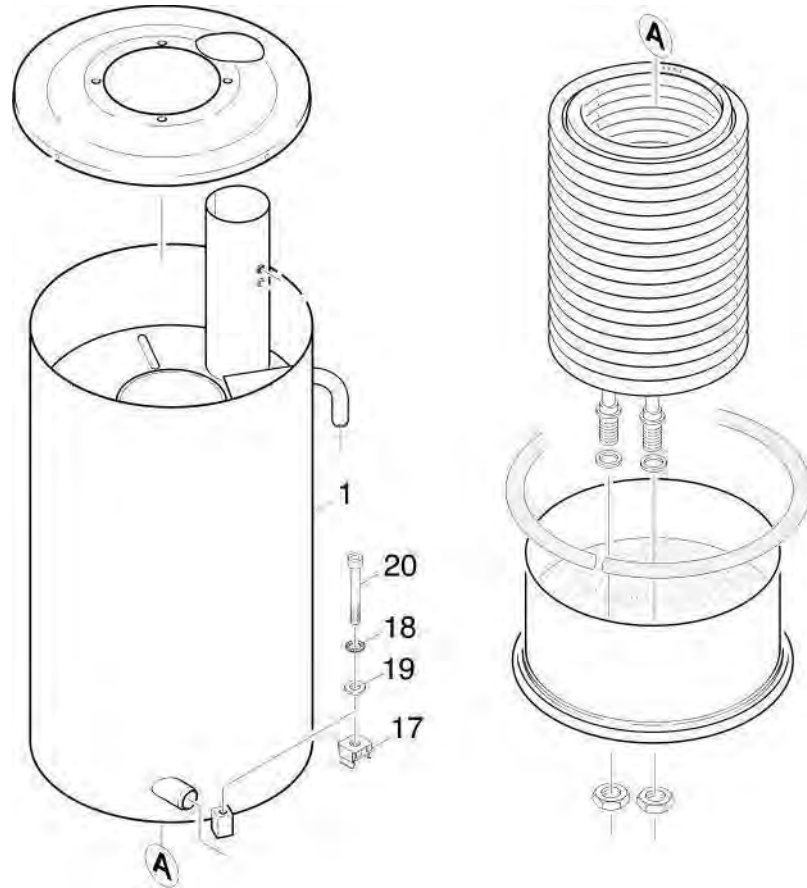
Note 1: The outer jacket (HDS 9/16 - 4.652-124 and HDS 12/14 - 4.652-142) cannot always be fitted closely onto the boiler base using the 3 fastening shackles, as the unit base can be distorted in the vicinity of the fastening screws.

Deformation of the unit base and possibly fastening points bent upwards.
Triggered by great forces of the boiler screws distributed on three small areas.

Fig. 1: The number of fastening shackles on the outer jacket will be increased in future from 3 to 6

In future, the outer jacket will be changed over from 3 to 6 fastening shackles, while retaining the part number. The existing stocks of old outer jackets will be used up. Additional parts are needed to fit the new outer jacket, see also Fig. 1:

No. 17: 3 ea. nuts M8 (7.311-068), standard version
No. 18: 3 ea. tooth lock washer 8.4 (7.312-159)
No. 19: 3 ea. washer 8.4 (7.312-004) and
No. 20: 3 ea. screws, M8 x 50 (7.306-039)

Note 2: The three additional fastening shackles must be marked and drilled to the unit base with $D = 9.0$ mm.

If necessary, before fitting the new parts, align any fastening points in the base unit that have been bent upwards, using a rubber hammer.

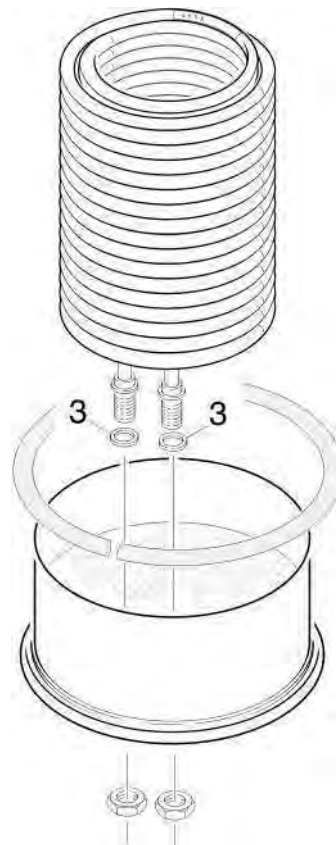
Note: The copper seals between the heating coil neck and boiler base are no longer impervious, leaking condensate and coolant.

Copper seals are used between the heating coil neck and the boiler base. Aggressive condensate in combination with the various metals corrodes them in time.

Fig. 1: Seal, No. 3 (5.115-521)
between heating coil and boiler base

When repairing the heating coil and boiler base or when there are leaks here, the two copper seals should be replaced by 2 plastic seals (5.115-521).

The paper seal featured in Disis as spare part (5.365-068) is not suitable for use in gas units.

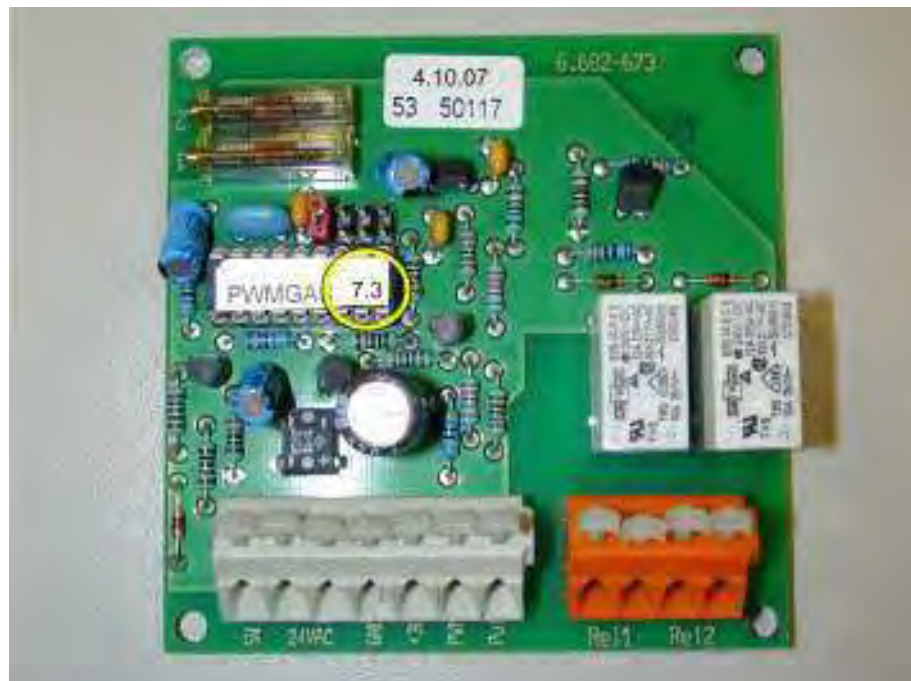
Note 1: Sometimes inexplicable faults occur in the burner, although the ionization electrode, burner setting and gas pressure are correct.

The PWM electronics module for controlling the fan speed can react sensitively to interference radiation and interference voltage. This can cause "false" burner faults.

Fig. 1: PWM electronics module (6.682-673) in the latest version with software version 7.3 (encircled)

The hardware and software of the PWM electronics module have been revised. The revised version which retains the same part number (6.682-673) is identified by version label 7.3 (encircled in Fig. 1).

Note 2: Burner faults caused by the PWM electronics module cannot be eliminated with the unlock button but only by switching off and on again with the main switch and then pressing the unlock button.
