**8. BDS 43/DUO C Adv****Motor 6.613-250.0****Service Bulletin****No. 2013-023 dated 30.10.2013****Classification level IV**

**4. BDS 43/DUO, 43/180****ABS tank 2.642-476.0****Service Bulletin****No. 2014-019 dated 20.11.2014**

**5. BDS 33..51/180..450****Modifications****Service Bulletin****No. 2014-019 dated 20.11.2014**

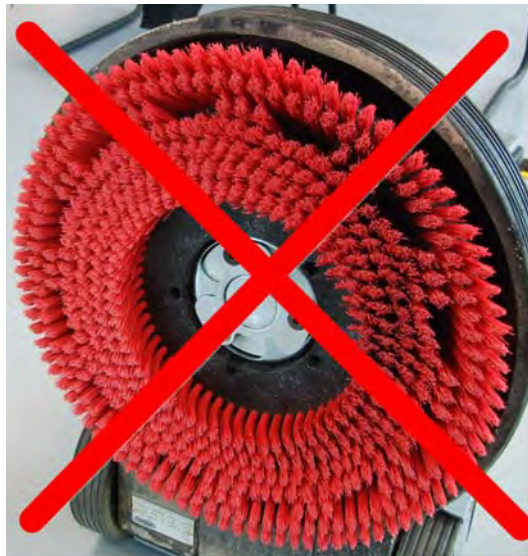
**Problem:** When operating at high speed, BDS 43/DUO can switch off again or not produce sufficient torque to start up at high speed. In both cases, the motor protection switch triggers.

**Cause:** Some motors 6.613-250.0 deviate clearly from the defined output.

*Fig.: Brushes must not be used in the high speed mode.*

**Solution:** Equivalent motors will not be available until week 4/2014 at the earliest, both in production and in the field. Until then, users are instructed to use an extension cable with a cross section of at least 2.5mm<sup>2</sup> and red pads. Only use clean pads; if necessary, raise the brush head a little while starting up. The high speed is only intended for polishing on suitable floors. Scrubbing or decoating may only be carried out at low speed.

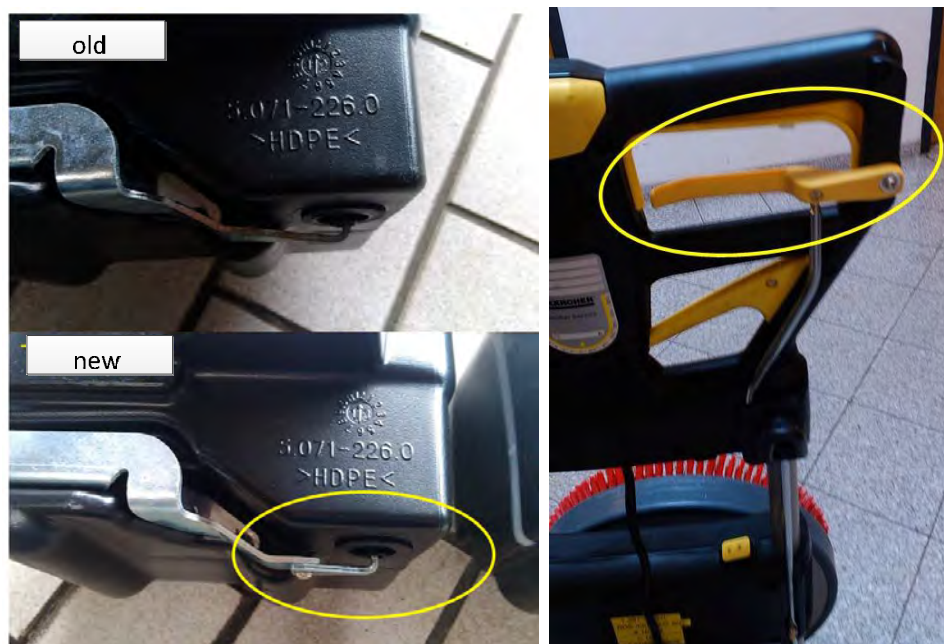
- Problem:** The mechanism for opening the water valve on the water tank is stiff with an insufficient flow of water.
- Cause:** Production tolerances resulted in the metal lever on the water tank coming against the tank after only a short lever distance so that the valve could no longer open wide enough. The same effect was caused by a metal rod being too long so that the control lever collided with the handle.

Figure: Control lever, rod, water valve lever and valve.

- Solution:** The design of the control lever and the metal rod was changed at the handle so that less force is needed. The water valve lever is now flatter in design so that it only comes against the water tank after a longer lever distance. The material of the new valve is harder and the water flow is higher than before. The harder material means that it is no longer possible to disassemble the valve. But it can also no longer be pressed unintentionally into the tank. The valve is also higher in position so that more water remains in the tank. Assembly instructions are supplied in the mounting kit.

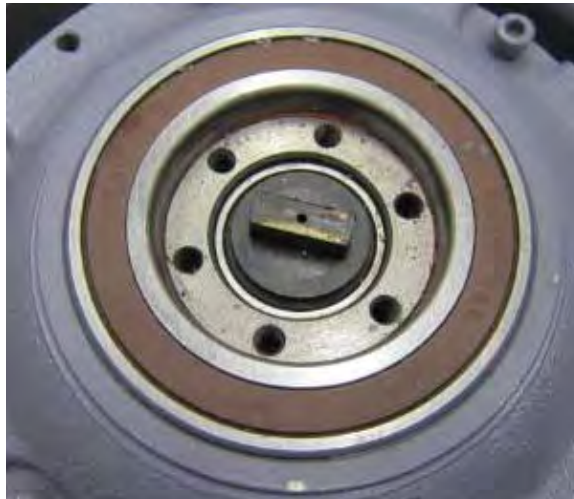
1. Under certain conditions, the BDS motor can switch off.
2. Vibrations can occur particularly in the 60 Hz range.
3. The shaft is not fixed in the transport position.

Figure: Coupling element with rubber-coated segments.

2. The elements of the transmission coupling are coated with rubber in variants 1.291-230.0, -231.0 and -232.0. The vibration-susceptible 60Hz units thus run more smoothly. In general, when vibrations occur attention should initially be paid to the

pad holders. The DUO pad holder 6.369-901.0 is usually sufficient as a solution for reducing vibrations. The rubber-coated coupling is not available as a replacement.

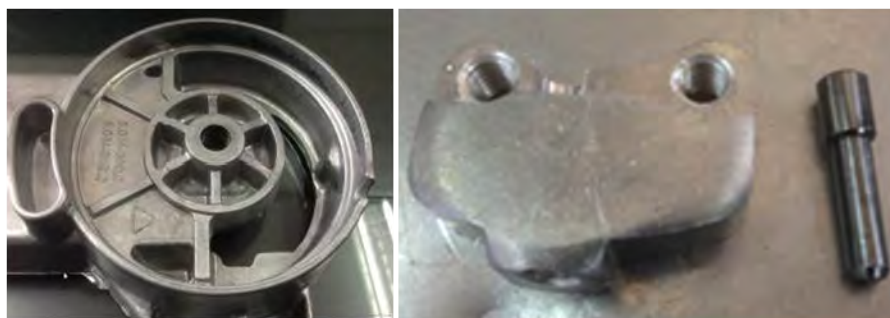
3. The locking pin 5.034-928.0 broke loose and therefore no longer fulfilled its function. The material and dimensions of pin and plate 5.044-019.0 have been improved (new pin 5.034-013.0, new plate 5.044-244.0). If the pin is replaced, the plate and the bracket on the left also have to be replaced.

The spare part number for the bracket will be announced in DISIS once it has become available.
