Service Bulletin
UBS metering pump

Service Bulletin No. 2005-026 dated 09.12.2005

Service Bulletin No. 2006-011 dated 02.05.06 Classification level III

Service Bulletin No. 2011-015 dated 18.11.2011

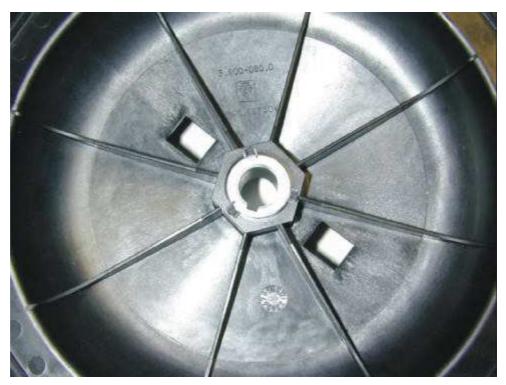
Problem: For the medium class units, the tolerance ring connection sometimes comes

loose or the fan wheel (5.600-045) breaks at the hub. Especially 60 Hz units

Cause: The tolerance ring connection is not process-sure. The rigidity of the plastic

material is not sufficient.

Picture 1: Fan wheel (5.600-080), outward-facing side

Solution 1: When a fan wheel malfunctions due to a loose tolerance ring connection or a

defect hub, repair set 2.641-021 is used.

Solution 2: In the series, all unit types of the current medium class since week 47/2005

were changed over to a fan wheel with a tongue and groove joint.

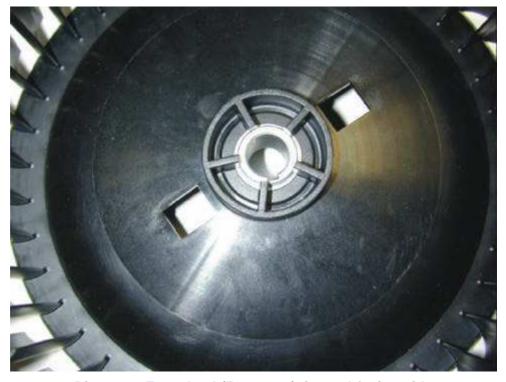
Picture 2: Fan wheel (5.600-080), inward-facing side

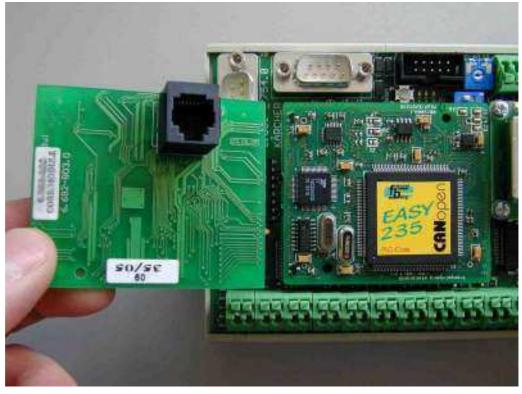
The basic settings on the printed circuit board do not remained saved there. After an electrical power outage or after the unit is turned off and on via the master switch, the operating data and setting values are missing under certain conditions.

The processor module is not always successfully initialised when the unit is switched on.

Figure 1: Printed circuit board (6.682-754) with processor module. Left: new processor module (6.682-803). When attaching, mind the correct position!

The processor module on the printed circuit board (6.682-754) was reworked in both hardware and software. If the problems described above occur, the new processor module (6.682-803) must be installed (see figure 1).

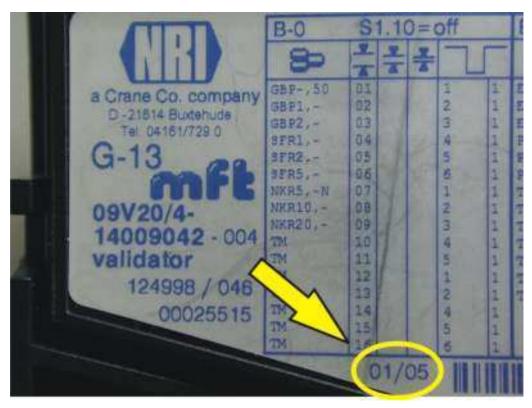
Problem: The electronic coin acceptor (6.768-333 or 2.884-218) accepts coins poorly

Cause: Moisture in the coin acceptor. Under the cover on the printed circuit board,

visible on the receptacle for the ribbon cable and the connection wires of the take-up reel. Spray protection flap on the outside of the machine for coin insert

Figure 1: Production date (month/year) on the rating plate.
Improved version from 03/06

Solution: Optical parts and the coating on the printed circuit board have been improved

The spray protection flap on the coin insert slot must be in order.

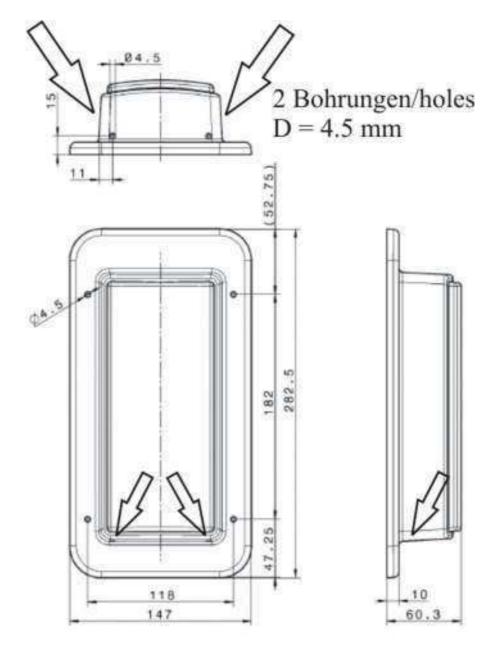
Fig. 1: The arrows show the position of the two holes. They can also be drilled simply in retrospect.

During the winter, the glass of the remaining value display can mist up. If a corresponding complaint is made, this can be prevented by subsequently drilling two vent openings (D = 4.5 mm) see Fig. 1.

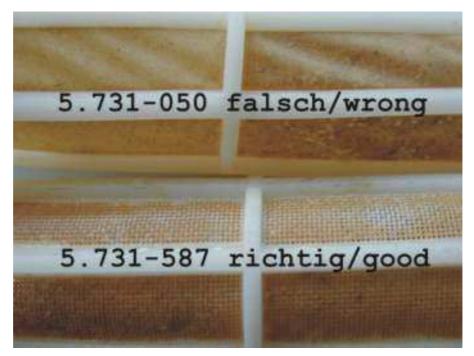
Fig. 1: Please only use the coarse filter 5.731-587 (in the lower picture)

Please only use filter (5.731-587), see Fig. 1. The wrong filter is too fine and therefore clogs up frequently. In addition, the centrifugal pump can overheat and/or the quantity of frost protection water is reduced to less than 0.5 l/min.

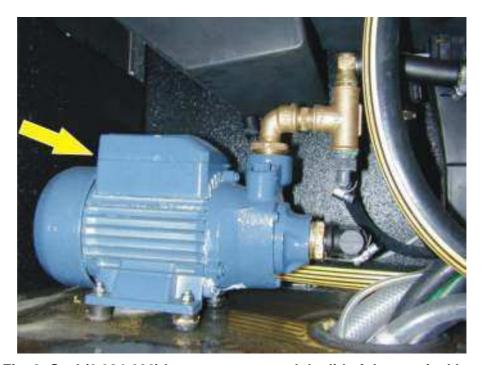
Fig. 2: Seal (6.984-606) between motor and the lid of the terminal box

Water penetrating the terminal box can cause failure of the centrifugal pump (6.743-482). This is why an additional seal (6.984-606) is inserted between the motor and the lid of the terminal box, see Fig. 2. This can be retrofitted to existing centrifugal pumps without any problems.

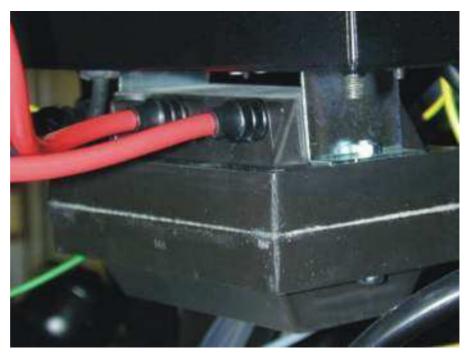
In early 2005, the ignition cable contacts under the same part number (4.821-071) were fitted with an additional index notch. This prevents the ignition cable from sliding out of the ignition transformer (Fig. 1).

Fig. 1: Plug-in connection ignition cable – ignition transformer

For safety reasons, when making repairs we advise using only ignition cables with index notch and inserting the ignition cables firmly in the ignition transformer. Ignition cables sliding out of the transformer can cause an electric arc and trigger a fire in the worst case.

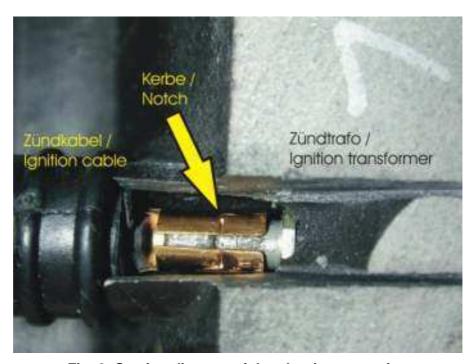
The index notch is visible when looking into the plug contact of the ignition cable, but cannot be shown in a photo. The index notch is shown in the section diagram (Fig. 2).

Fig. 2: Section diagram of the plug-in connection ignition cable – ignition transformer.

Use only ignition cable with index notch.
