Piston Service Bulletin

1. HD 9/20, HD 10/25, HD 13/18 Piston (4.553-279 /-280 /-282)

Service Bulletin No. 2008-010 dated 06.08.2008 Classification level III

Contactor 6.632-334 / -356 PCB 6.682-653 / -672/-801/-848

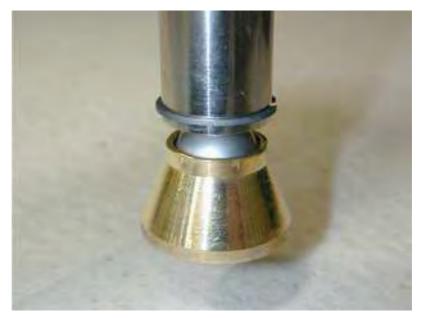
Fig. 1: Piston with piston shoe pressed on

Problem: In some units, piston shoes have come away from the piston.

Cause: In some cases the piston shoe was inadequately pressed on.

Solution: The assembly tools in the production process have been revised to guarantee that the piston shoes are adequately pressed onto the piston.

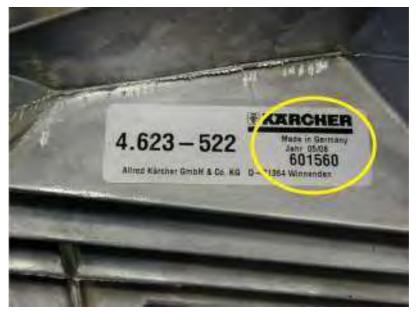
Fig. 2: Motor nameplate with production date (example 05/08)

with pump set, produced between 01.09.07 and 31.12.2007. This corresponds to 09/07 to 12/07 on the motor nameplate, see Fig. 2.

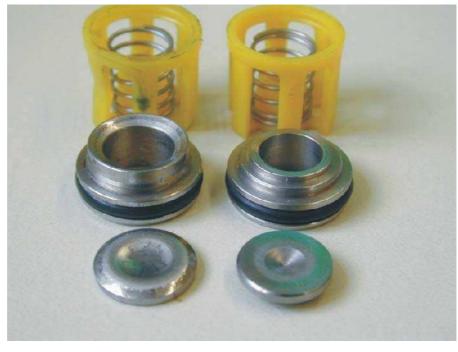
4580295.jpg

On left: Conical valve (4.580-295)

Advantages: Long service life, quiet, good flow properties.

Disadvantage: Less suitable as just a non-return valve.

On right: Flat valve (4.580-379)

Advantage: Very suitable as just a non-return valve.

Disadvantage: Loud, low flow rate, short service life, expensive production.

Tests have shown that the conical valves have several advantages over the flat valves. Therefore, the flat suction and pressure valve (4.580-379) is no longer displayed as a spare part in the Disis. In future only the conical valve (4.580-295) should be used as a spare part.

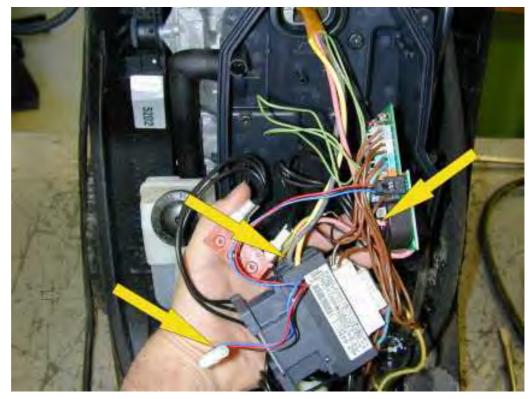
Fig. 2

- Take the electrical components out carefully
- Disconnect the contactor (pink T3, yellow T2, black T1)
- Thread the pink cable through the PCB
- Carefully pull out the control lamp

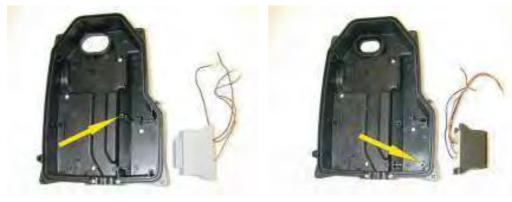
Fig. 5: Electrical box with **new** transformer

Fig. 6: Electrical box with **old** transformer

Caution: Use the screw contained in the set for fastening the new transformer. The new screw 6.303-328 (3x12 mm) is smaller in size than the old screw.

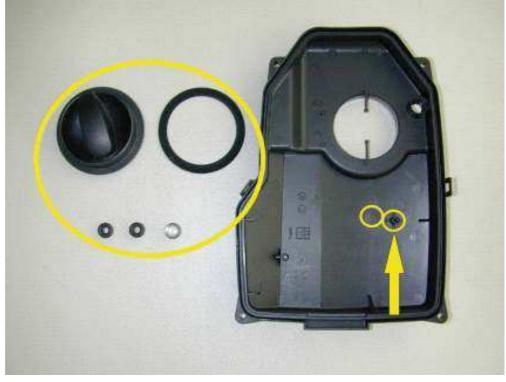
Fig. 13 Mounting parts

Electrical box cover as in set

Fig. 13 shows the change in the electrical box cover marked with an arrow. This holder has been moved 20 mm to the right. The contactor is now held at the base so that it can no longer bend.

Electrical box cover is without mounting parts. Please take the following parts from the old cover.

- 6.641-446 2 x rubber grommet for contactor and transformer holder
- 6.651-506 1 x oval head housing for control lamp
- 5.363-616 1 x seal for rotating handle
- 5.321-719 1 x rotating handle
- 7.303-109 4 x screws for electrical box cover (not shown)

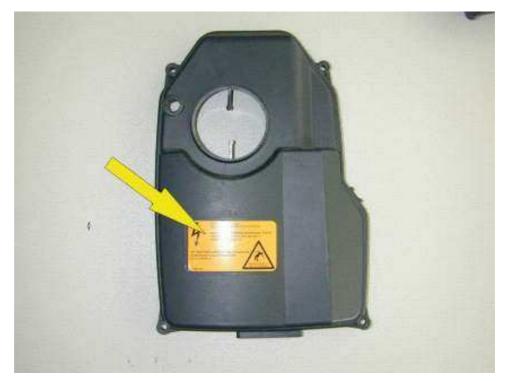
Fig.14

Caution: Adhere safety warning 5.388-512 to the new electrical box cover.

This adhesive warning is included in the set; it is absolutely vital that it is adhered to the provided panel on the new electrical box cover.
