## 2. NT 35/1- NT 55/1 Magnet 6.653-009.0

## Service Bulletin No. 2013-005 dated 07.06.2013 Classification level IV

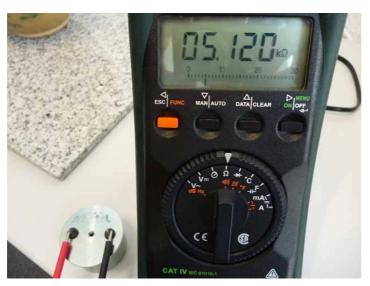
Figure 1

Every magnet must be checked before being replaced. Disconnect the magnet from the unit. Perform the continuity test with a suitable testing tool.

The measured value ranges from 5.0 to 5.5 k $\Omega$  (Fig. 1).

The magnet has to be replaced if the value is not measured and is way beyond the stipulated range.

Additional mechanical check: The magnet most be moved quickly back and forth. The magnet has to be replaced if the magnet coil moves in the metal housing.
